ADA Presentation

FY 21/22 ADA Projects

Human Resources Department

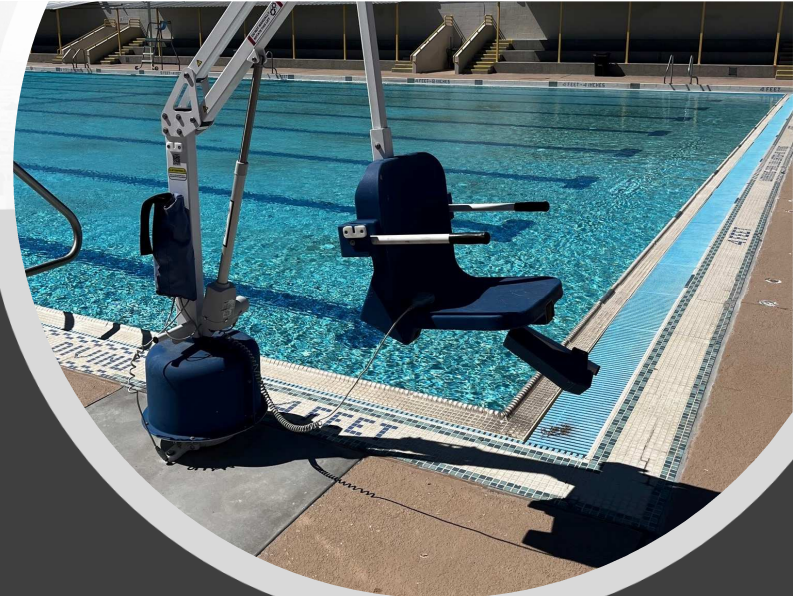
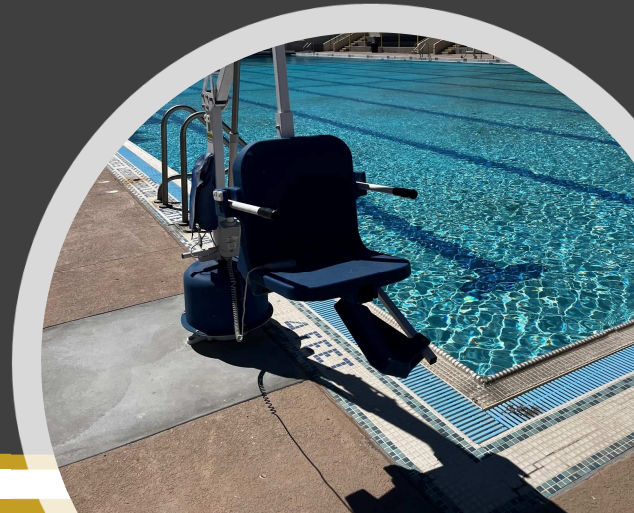
Pool Chair Lifts

- Ascarate Pool
- Gallegos Pool
- Fabens Pool

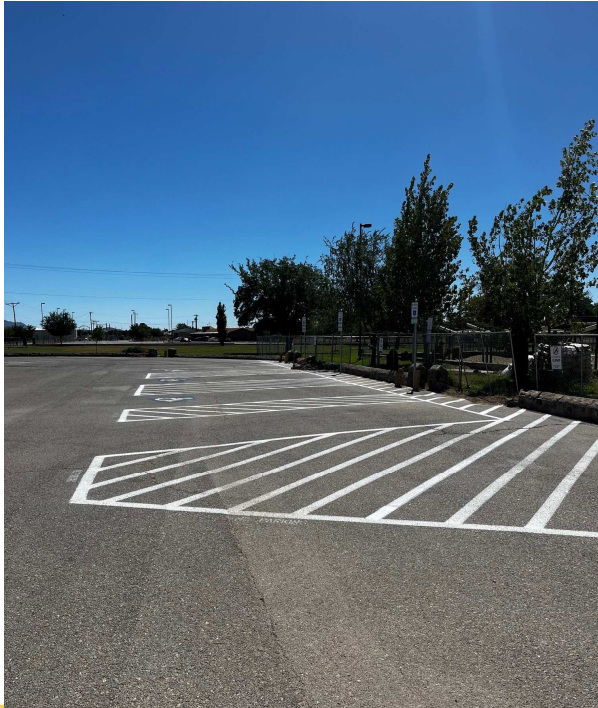
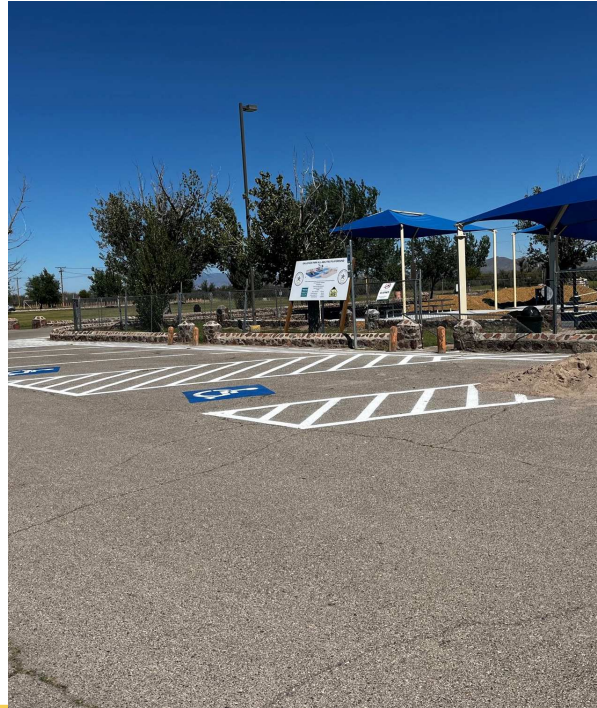
Gallegos Park

- 12 Total Spaces
- 5 Accessible Spaces
- 3 Van Accessible

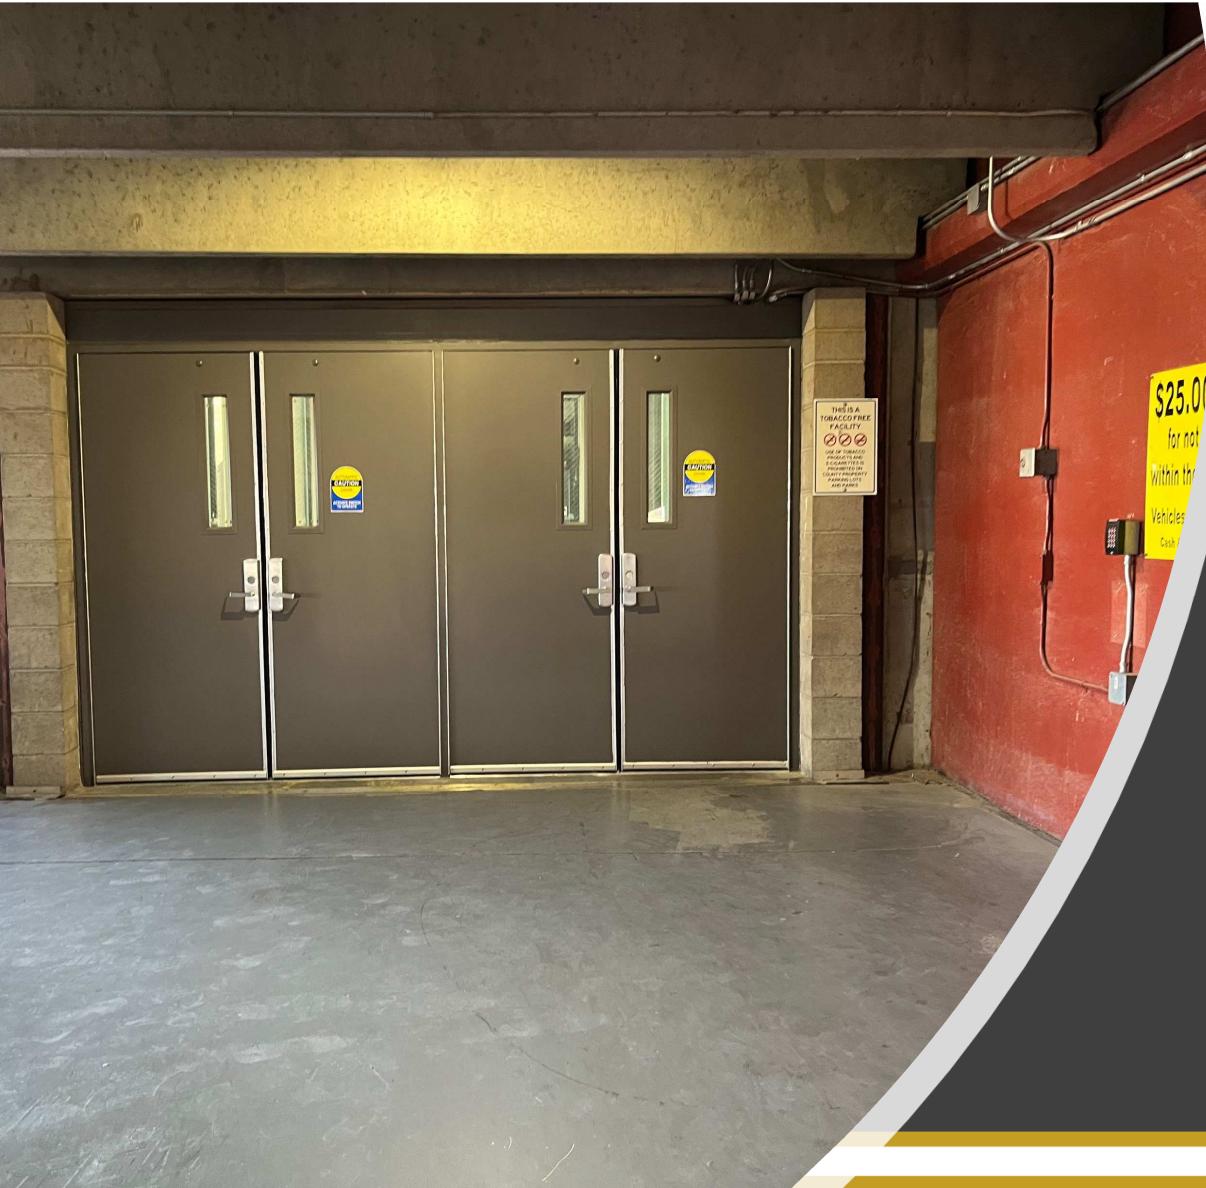
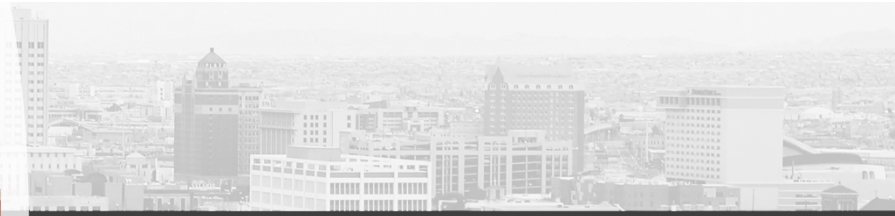
Courthouse

- Skywalk Doors
- Restrooms
 - 1st & 3rd Floor Men's & Women's
 - 5th Floor Men's

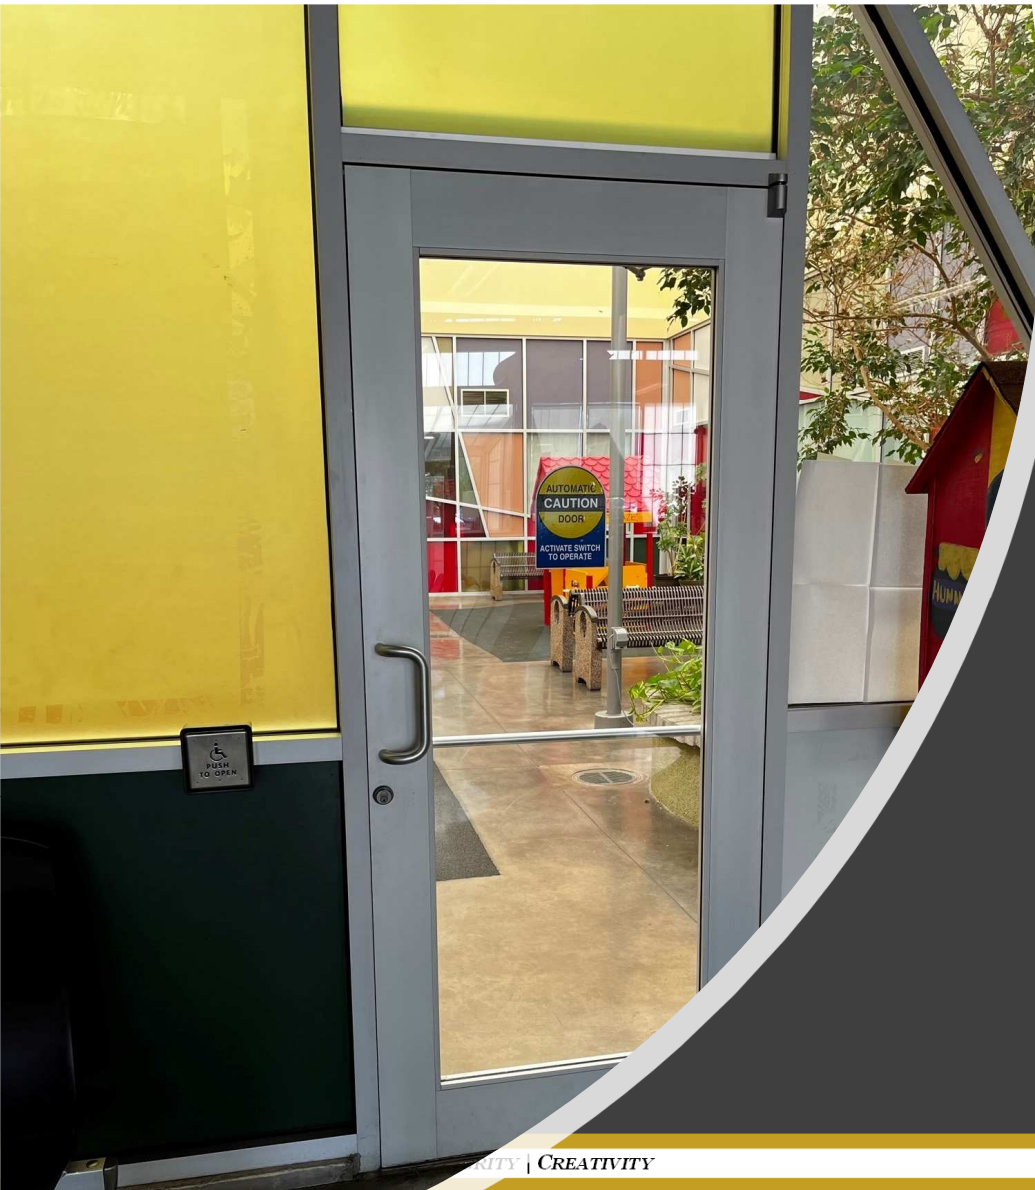
Youth Service Center

- Door Opener
- Door Clearance
