ADA Presentation

FY 21/22 ADA Projects

Human Resources Department

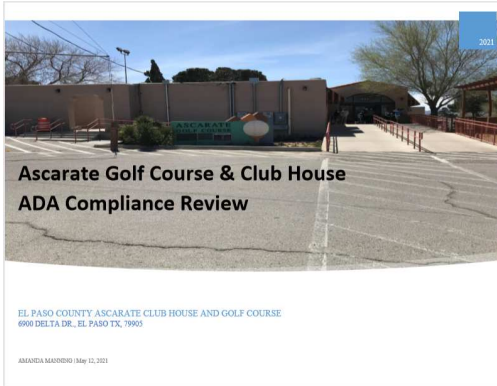
In the review of the the Ascarate Golf Course and Club House, located at 6900 Delta Dr., El Paso Texas 79905, a systematic approach was taken. The review began with the parking area in front of the club house and progressed through the following areas: the building approach and entrance, the lobby area, restrooms, and locker rooms. The golf course was also inspected for compliance with the following items inspected: teeing grounds, putting greens, weather shelters, accessible routes, barriers, and practice areas. At the time only the public areas were reviewed for compliance with the Texas Accessibility Standards (TAS) and the Americans with Disabilities Act Accessibility Guidelines (ADAAG).

The areas inspected for compliance are based on the Department of Justice's (DOJ) priority list and are as follows: Approach and Entrance (parking, route of travel up to and into the building); Access to Goods and Services (horizontal circulation corridors and doorways, vertical circulation elevators); Restrooms, and Additional Access (other features such as drinking fountains).

The following report lists the deficiencies of elements in each of the priority areas and what the code requires to make them compliant with the TAS and ADAAG.

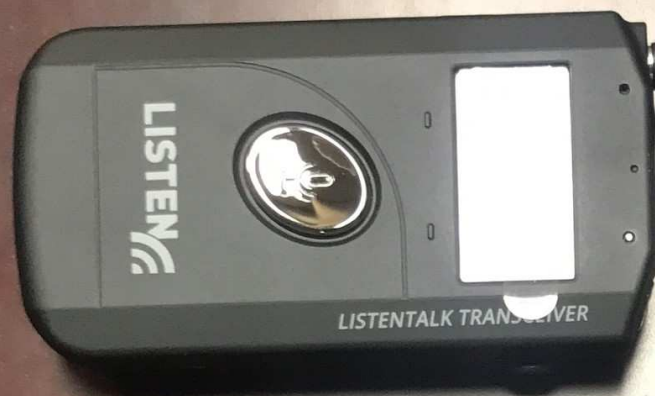
Assisted Listening Devices

- County Courthouse
