El Paso County Stormwater Master Plan

February 2021

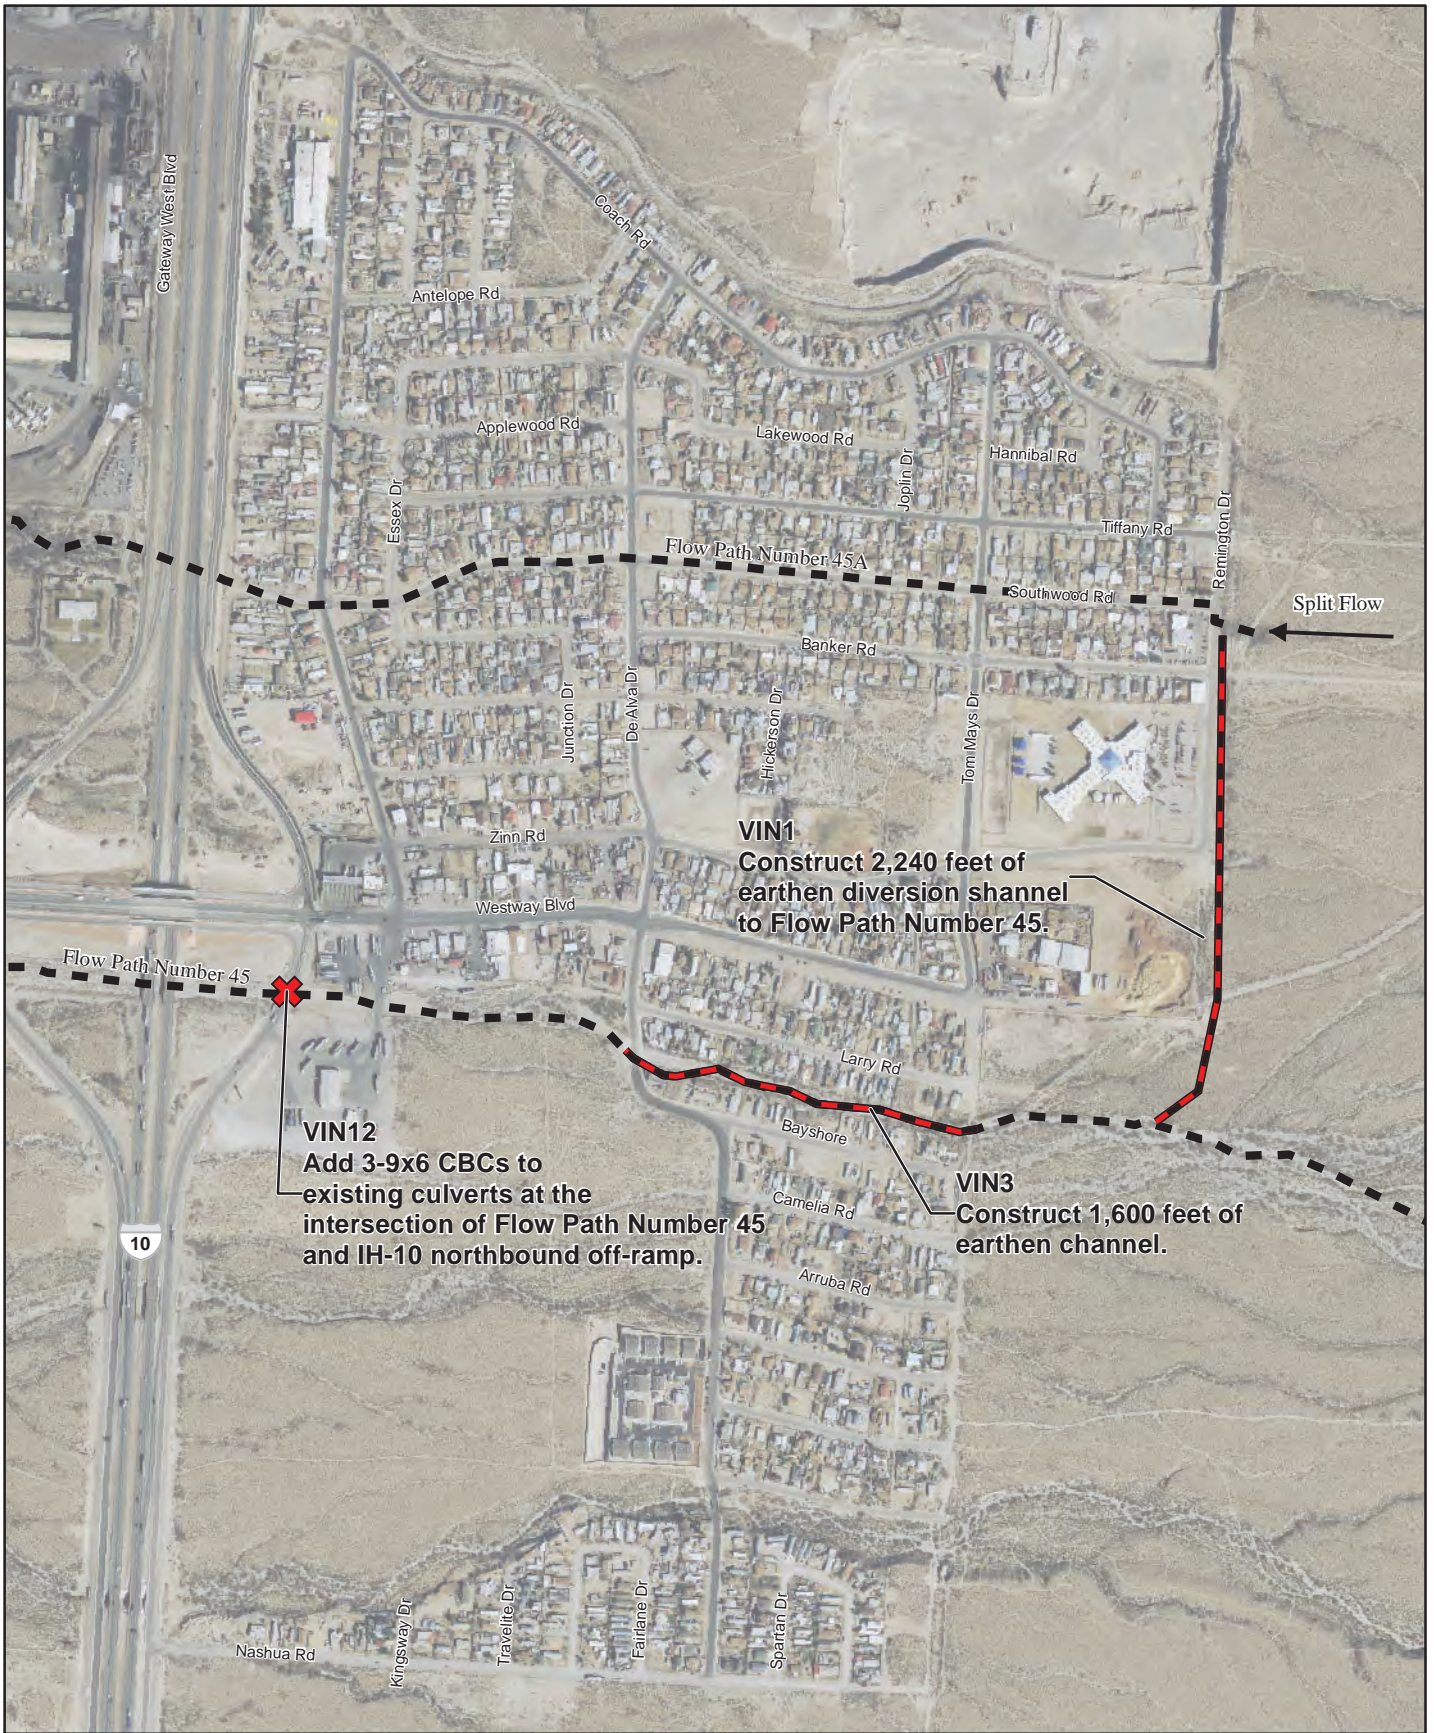
VIN1
Construct 2,240 feet of earthen diversion channel to Flow Path Number 45.

VIN12
Add 3-9x6 CBCs to existing culverts at the intersection of Flow Path Number 45 and IH-10 northbound off-ramp.

Figure 6-1 shows Flow Path Number 45 and a tributary to Flow Path Number 45 in the area immediately upstream of the El Paso Natural Gas (EPNG) Pipeline Road. Immediately upstream of the intersection of this tributary with the road, flows from the tributary split during floods, with the bulk of the flows proceeding southwest to the junctions with Flow Path Number 45. The remainder of the flood flow in this tributary heads due west across Westway Boulevard and the EPNG Pipeline Road. This flow is marked “Split Flow” on Figure 6-1. This “Split Flow” is shown on Figure 6-2 arriving from the east and entering Vinton near Banker Road, Flow Path Number 45A, and their intersection with Remington Drive. The “Split Flow” exceeds the capacity of the existing Flow Path Number 45A and causes flood damages in this part of Vinton and downstream to the immediate west.

Project VIN1 incorporates three improvements to address this issue. Basin A (Figure 6-1) is designed to capture flood flows and sediment from the tributary to Flow Path Number 45. A diversion channel (Figure 6-2) is designed parallel to and upstream of Remington Drive to intercept flood flows from the watershed downstream of Basin A. This diversion channel discharges into Flow Path Number 45 upstream of Tom Mays Drive. The diversion would increase flood flows in Flow Path Number 45 without a linked improvement along that channel. Basin B (Figure 6-1) is the proposed improvement on Flow Path Number 45. This basin intercepts flood and sediment flows from Flow Path Number 45; resulting in a net reduction of flows into Vinton along Flow Path Number 45. Project VIN3, which is for channel improvement within Vinton along Flow Path Number 45, is dependent upon the flow reductions achieved by Basins A and B.

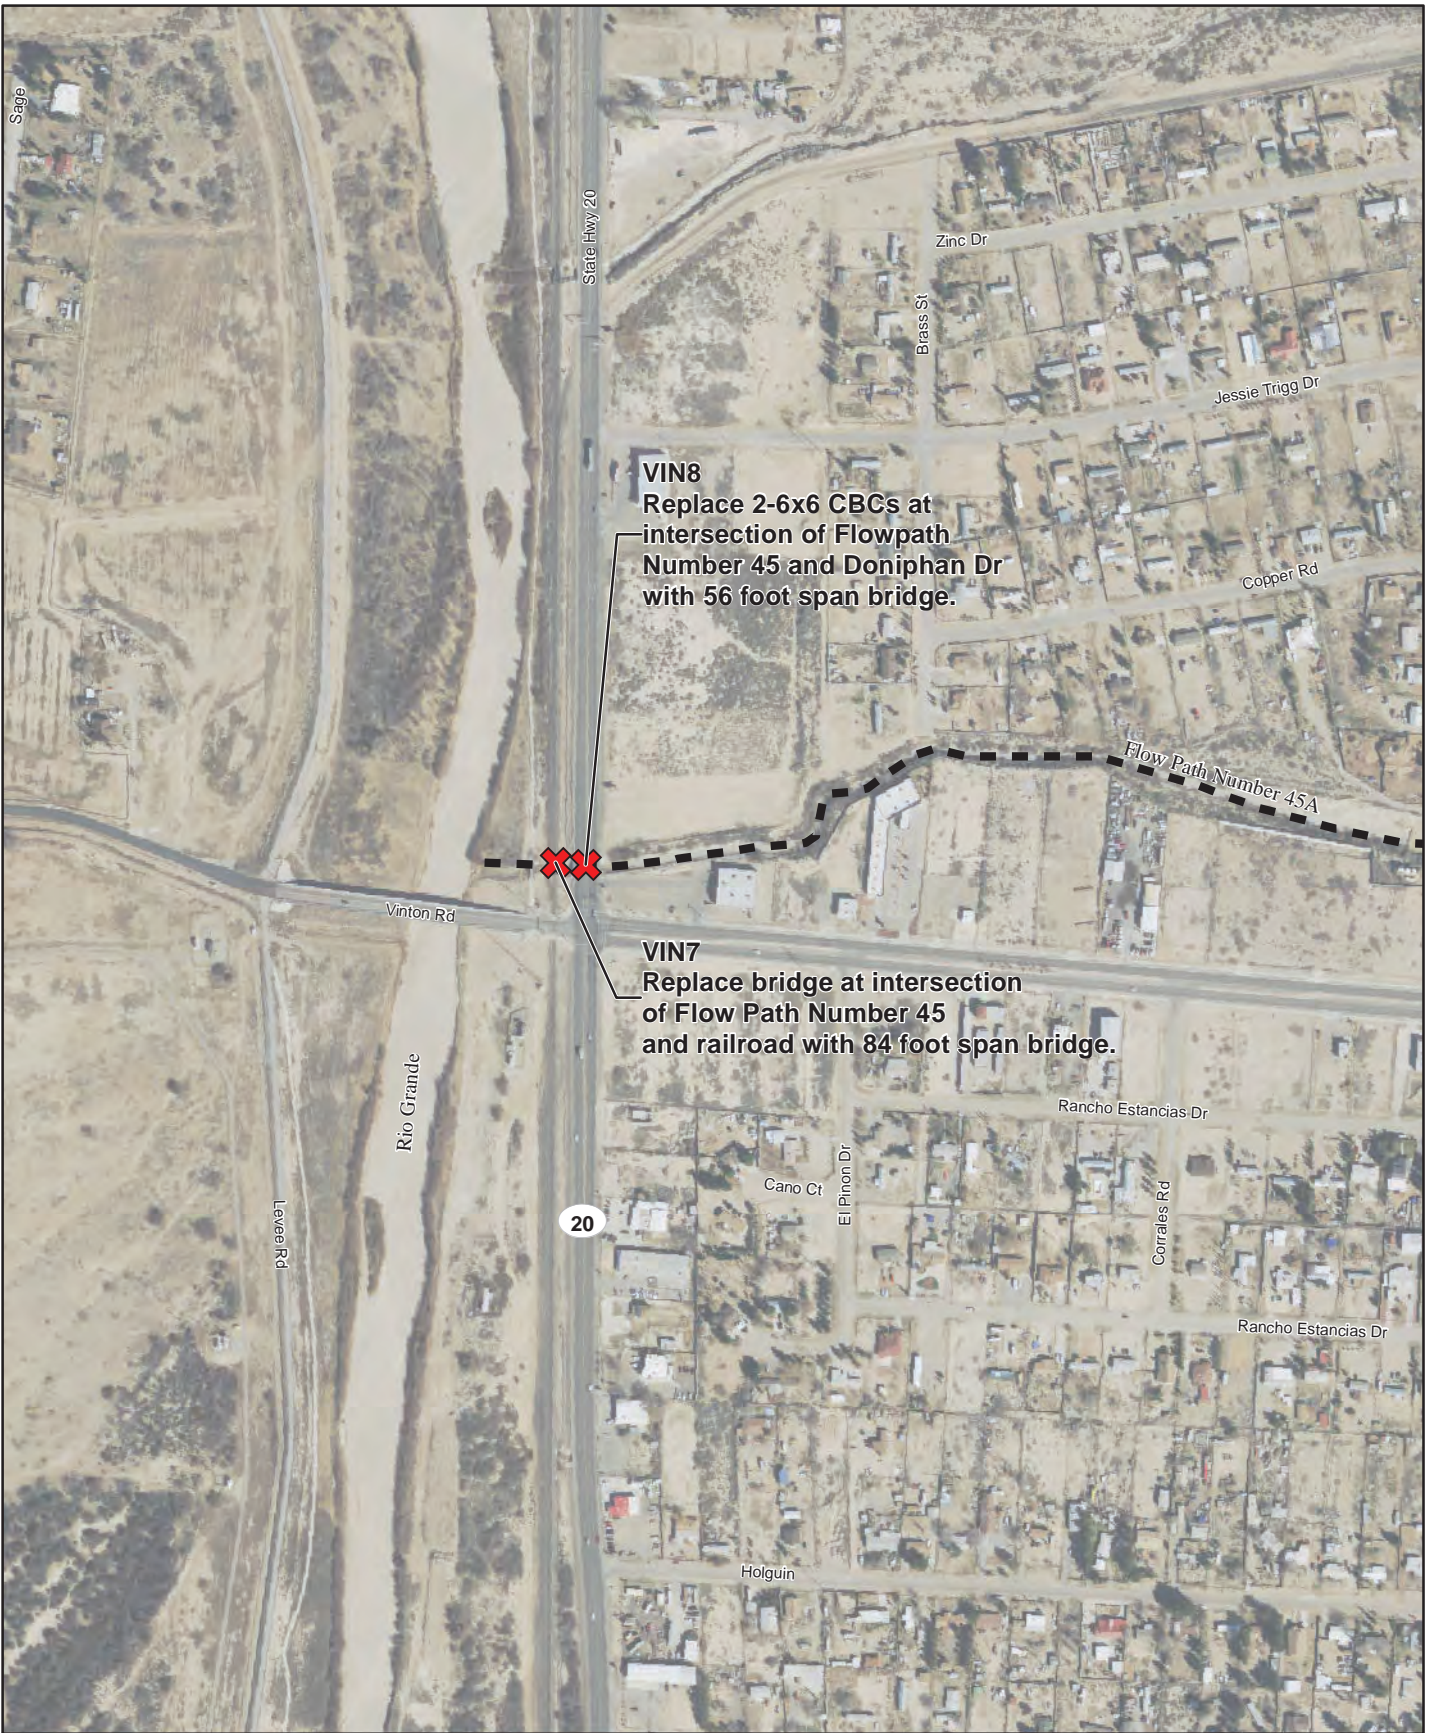
VIN8
 Replace 2-6x6 CBCs at
 intersection of Flowpath
 Number 45 and Doniphan Dr
 with 56 foot span bridge.

VIN7
 Replace bridge at intersection
 of Flow Path Number 45
 and railroad with 84 foot span bridge.

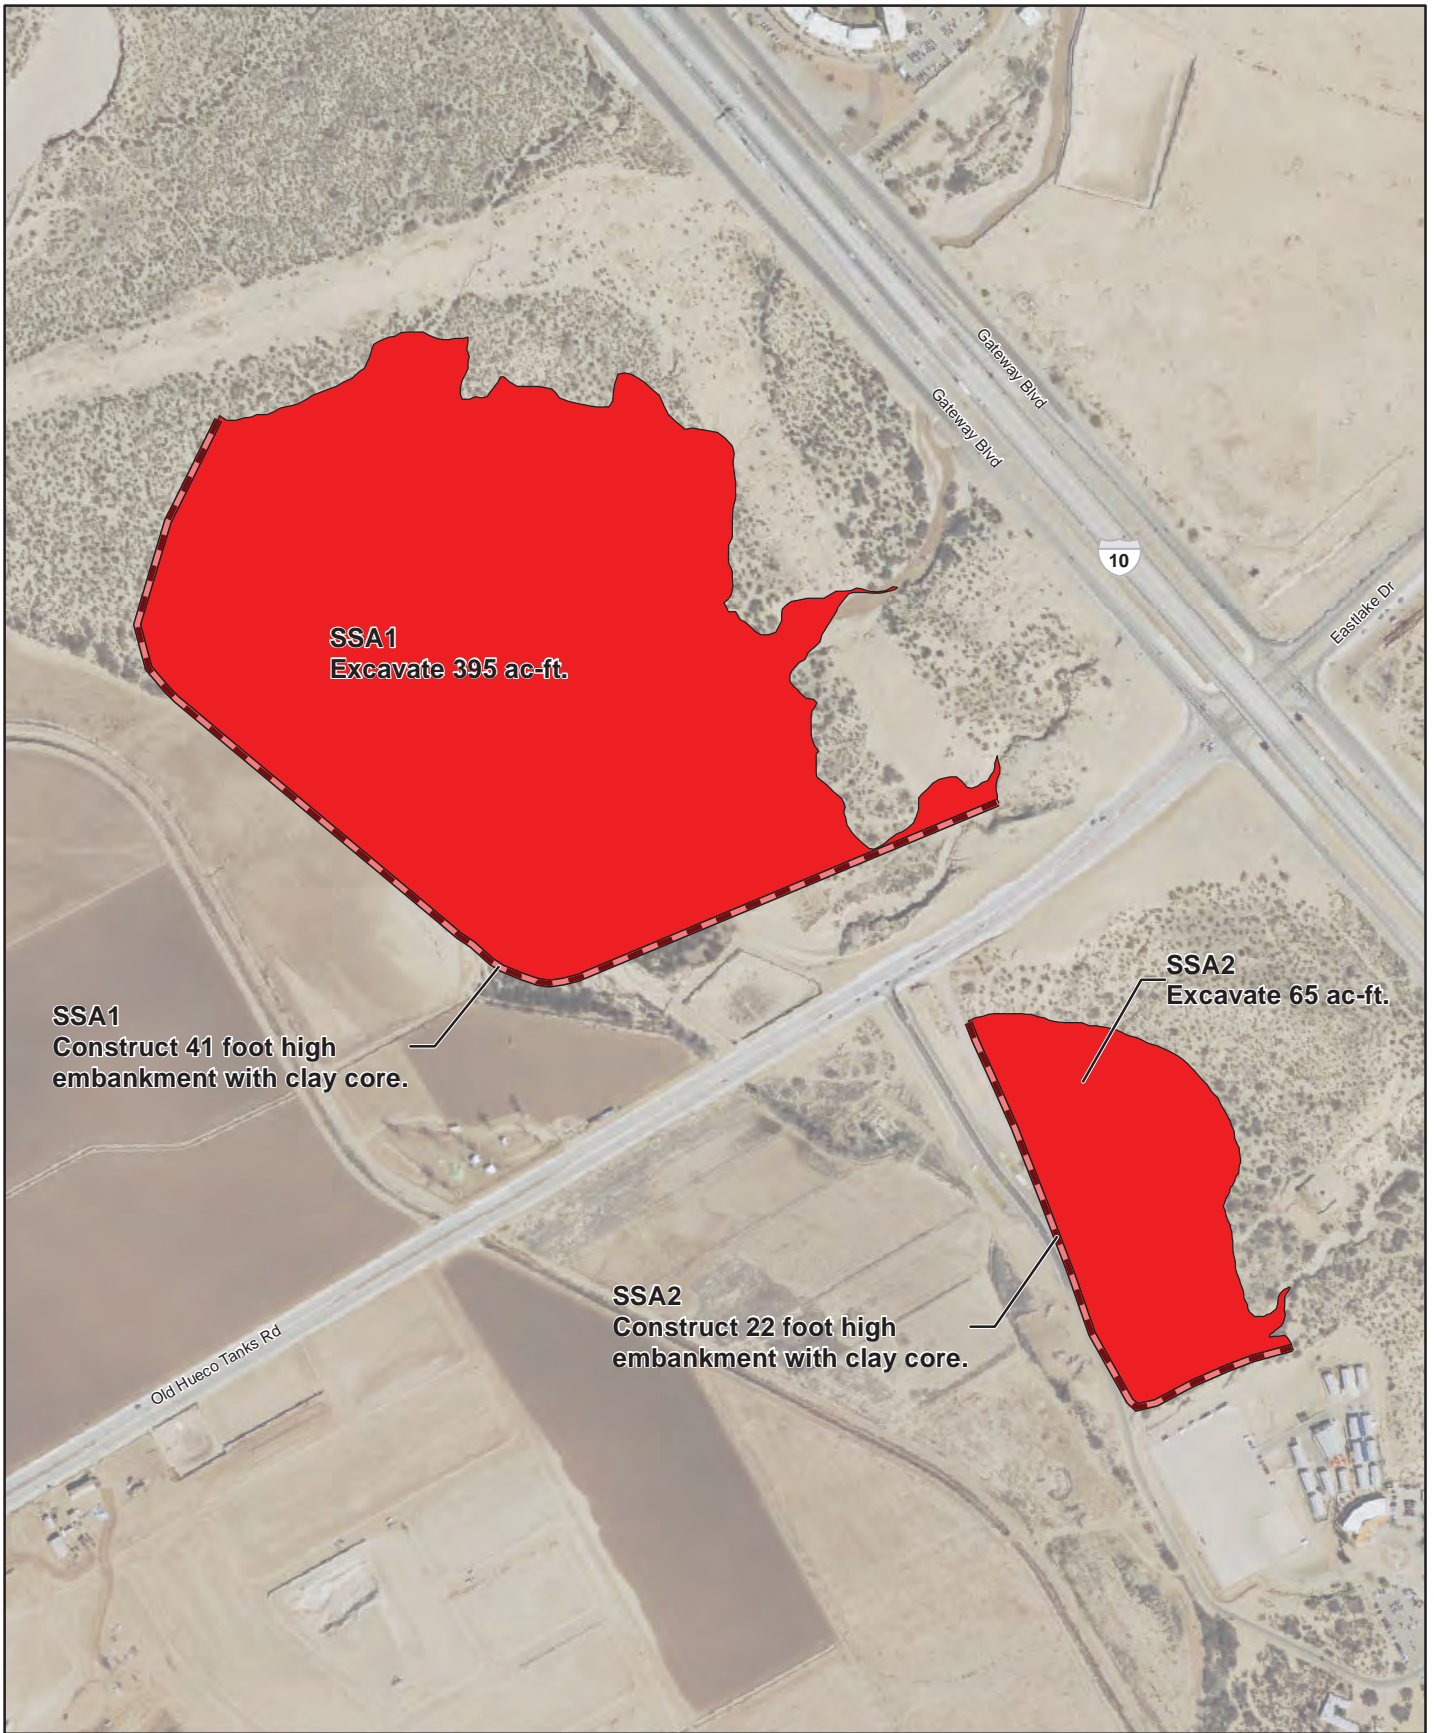
SSA1
Construct 41 foot high embankment with clay core.

SSA1
Excavate 395 ac-ft.

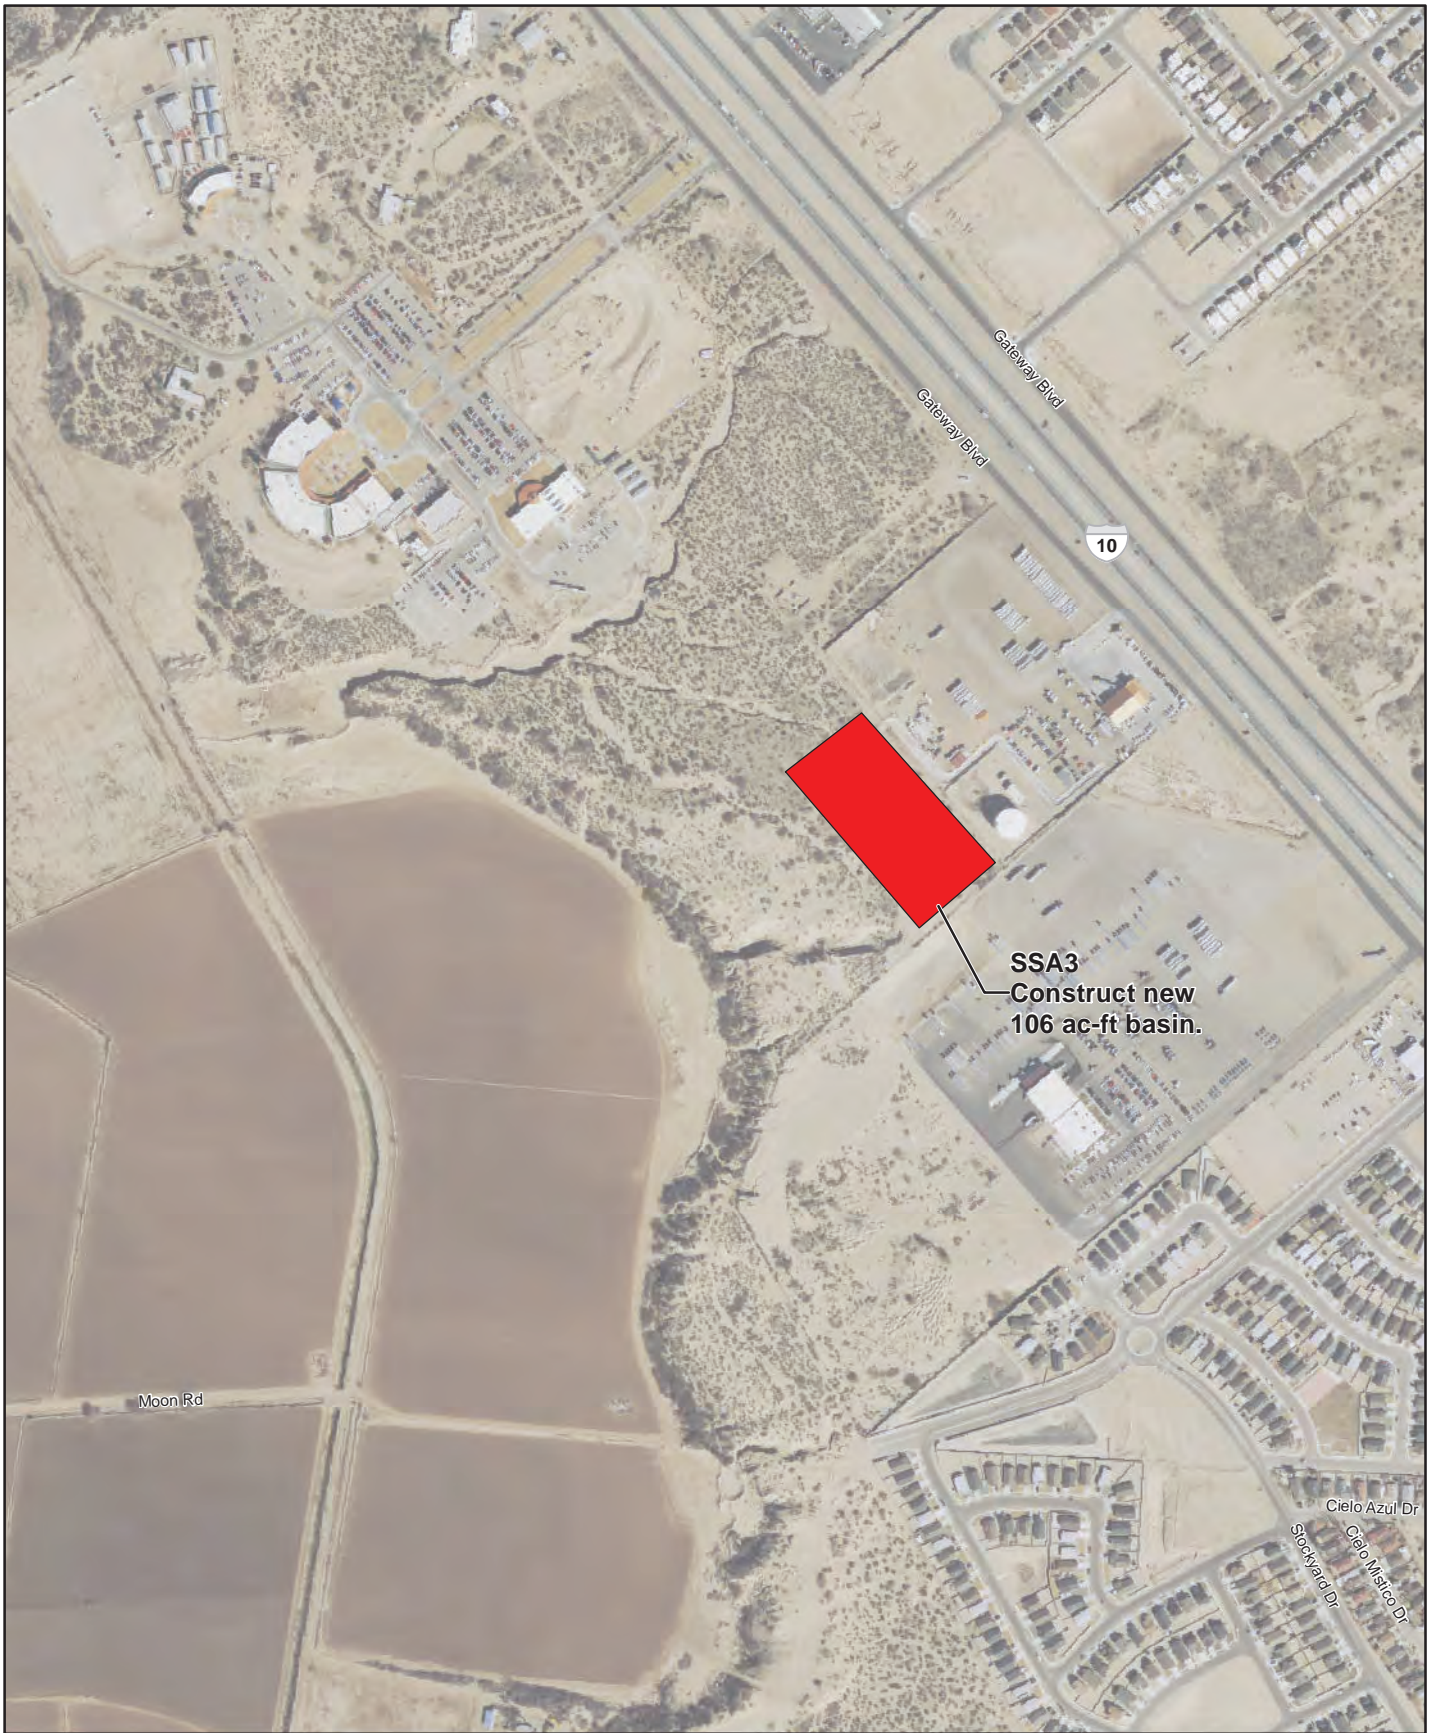
SSA3
Construct new
106 ac-ft basin.

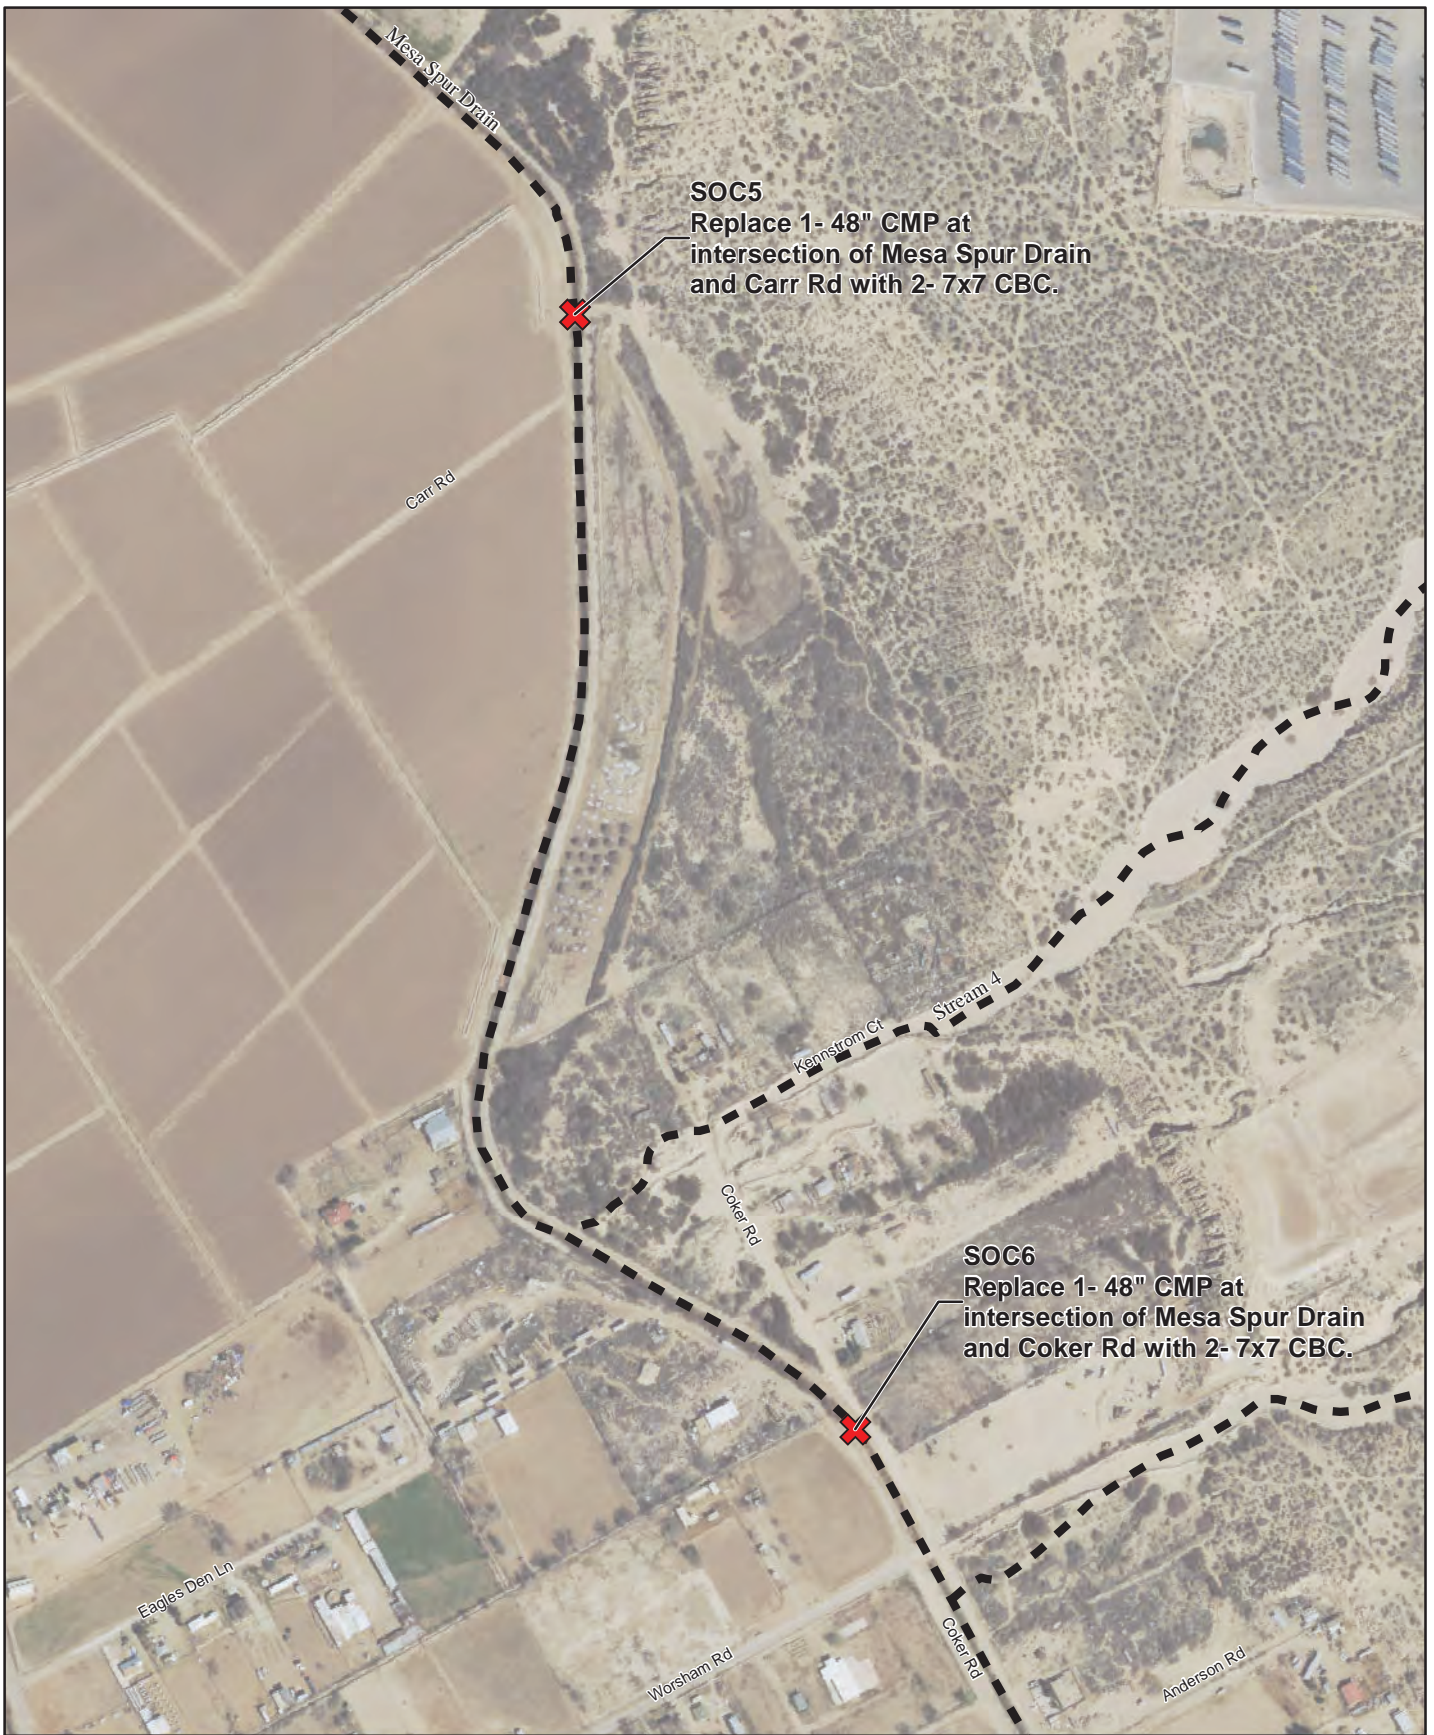
Figure 6-16

SOC5
 Replace 1- 48" CMP at
 intersection of Mesa Spur Drain
 and Carr Rd with 2- 7x7 CBC.

SOC6
 Replace 1- 48" CMP at
 intersection of Mesa Spur Drain
 and Coker Rd with 2- 7x7 CBC.

This project involves removing the existing 48-inch CMP culvert at the intersection of the Mesa Spur Drain and Coker Road and replacing it with two 7-foot by 7-foot CBCs. This culvert size provides capacity equal to or greater than that of the upstream channel. Although this crossing was not identified as a problem crossing by the County, this project was included because the existing culvert could restrict the flow of the channel if it were flowing bank-full. These proposed improvements are shown on Figure 6-16.

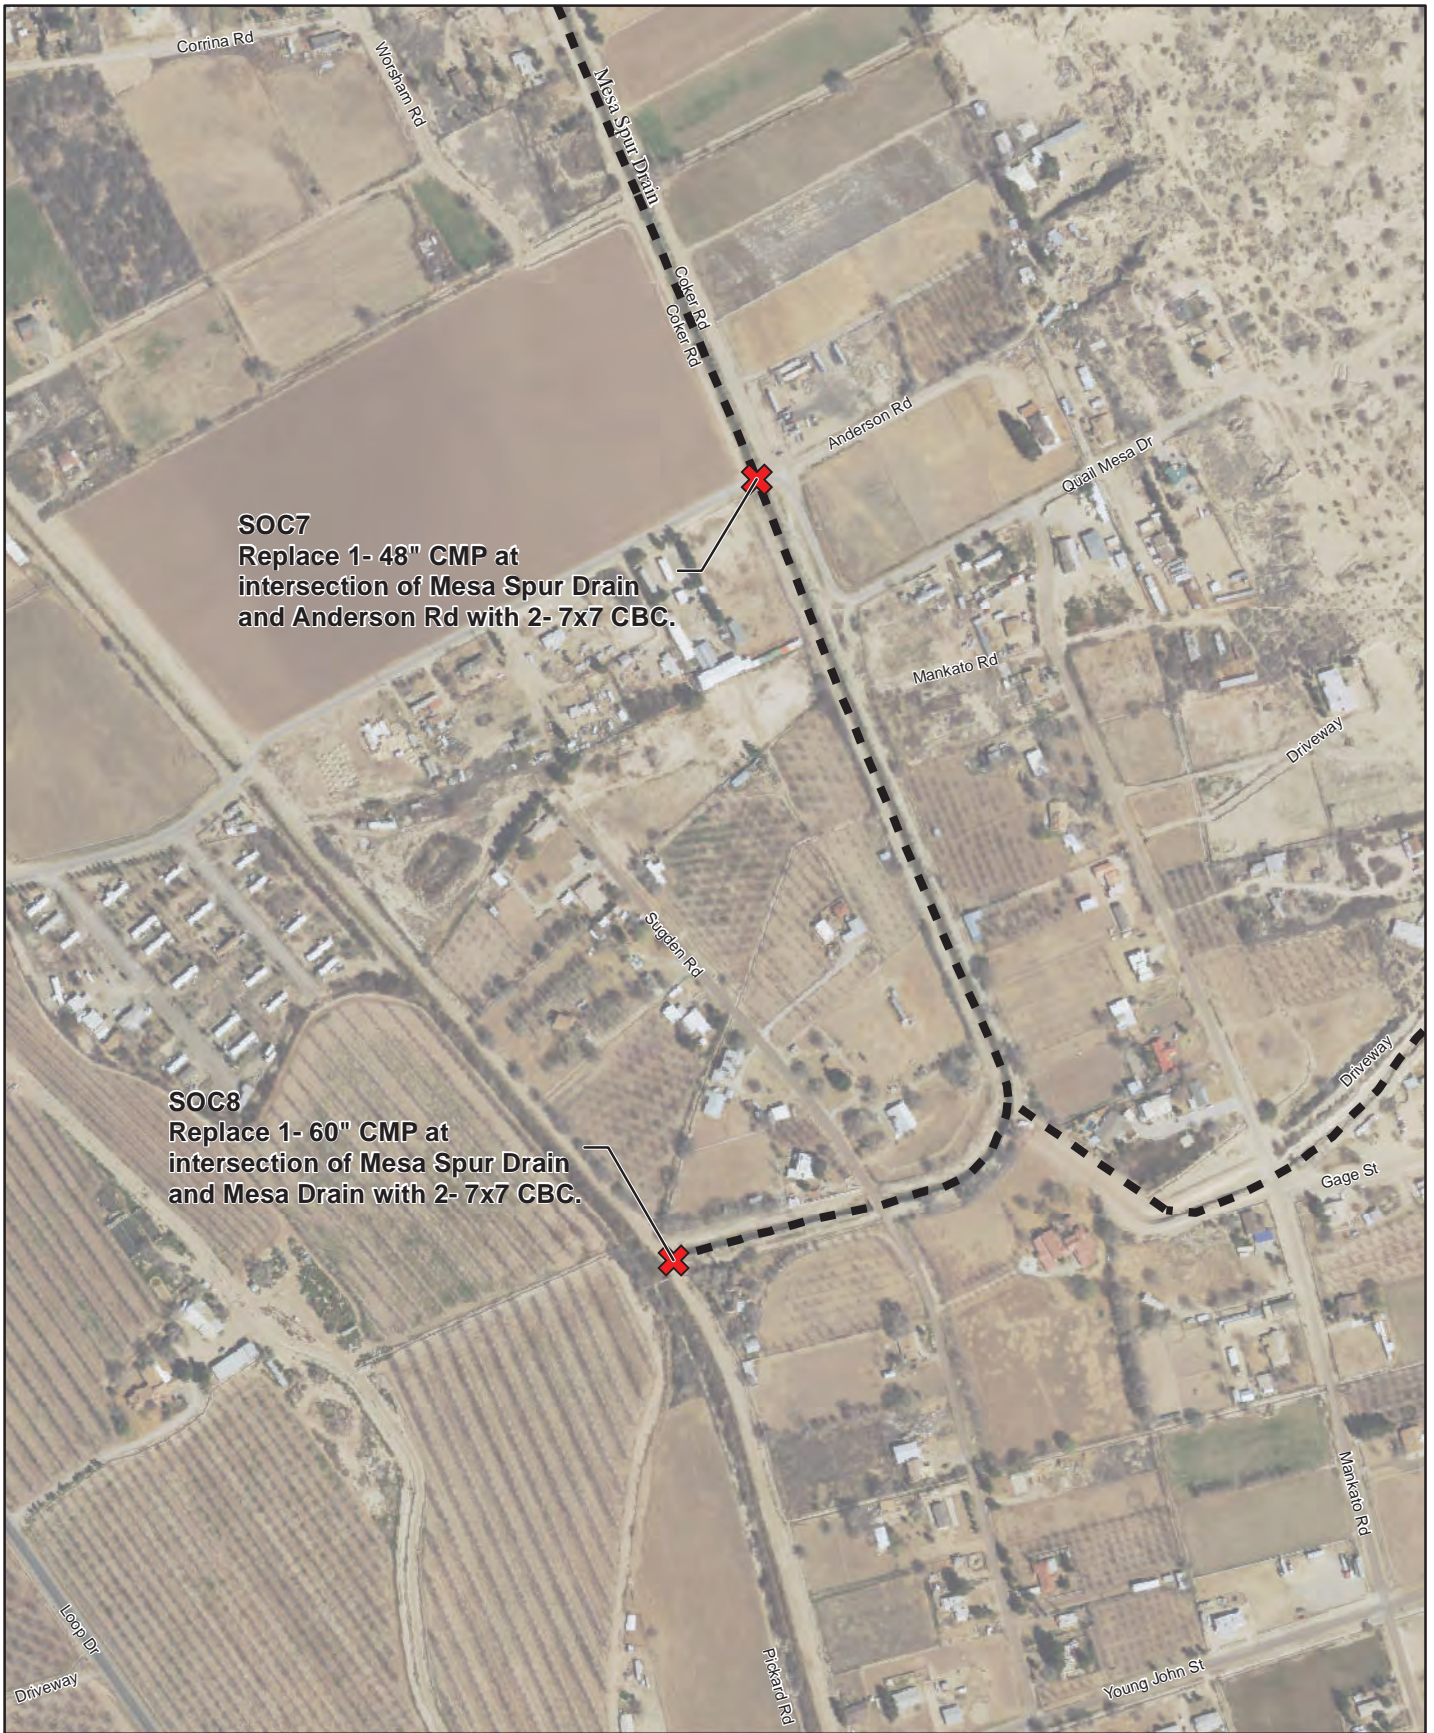
Figure 6-17

SOC7
 Replace 1- 48" CMP at
 intersection of Mesa Spur Drain
 and Anderson Rd with 2- 7x7 CBC.

SOC8
 Replace 1- 60" CMP at
 intersection of Mesa Spur Drain
 and Mesa Drain with 2- 7x7 CBC.

This project involves removing the existing 48-inch CMP culvert at the intersection of the Mesa Spur Drain and Anderson Road and replacing it with two 7-foot by 7-foot CBCs. This culvert size provides capacity equal to or greater than that of the upstream channel. Although this crossing was not identified as a problem crossing by the County, this project was included because the existing culvert could restrict the flow of the channel if it were flowing bank-full. These proposed improvements are shown on Figure 6-17.

This project involves removing the existing 60-inch CMP culvert at the intersection of the Mesa Spur Drain and the Mesa Drain and replacing it with two 7-foot by 7-foot CBCs. This culvert size provides capacity equal to or greater than that of the upstream channel. Although this crossing was not identified as a problem crossing by the County, this project was included because the existing culvert could restrict the flow of the channel if it were flowing bank-full. These proposed improvements are shown on Figure 6-17.

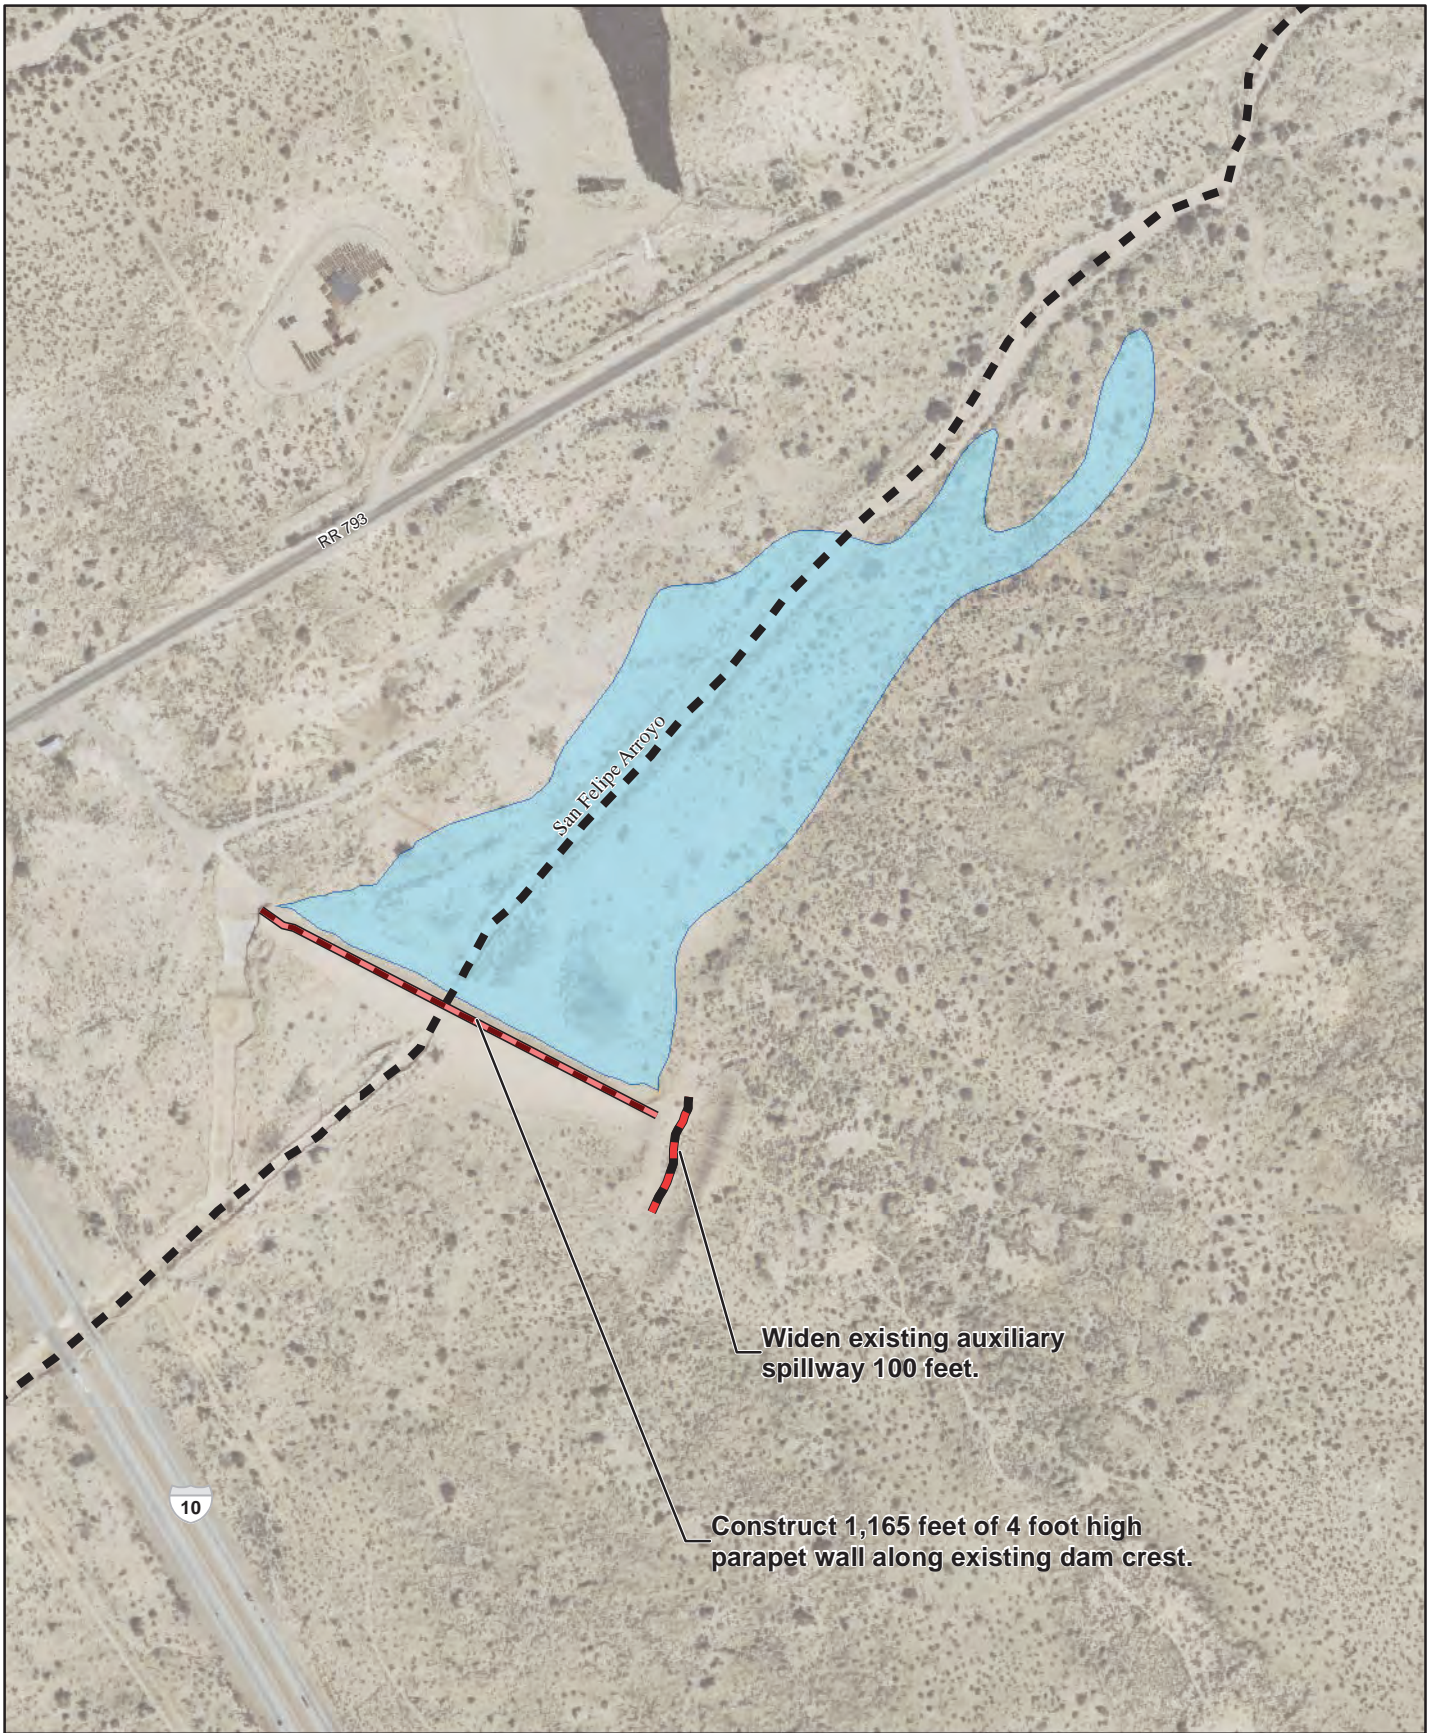
Widen existing auxiliary spillway 100 feet.

Construct 1,165 feet of 4 foot high parapet wall along existing dam crest.

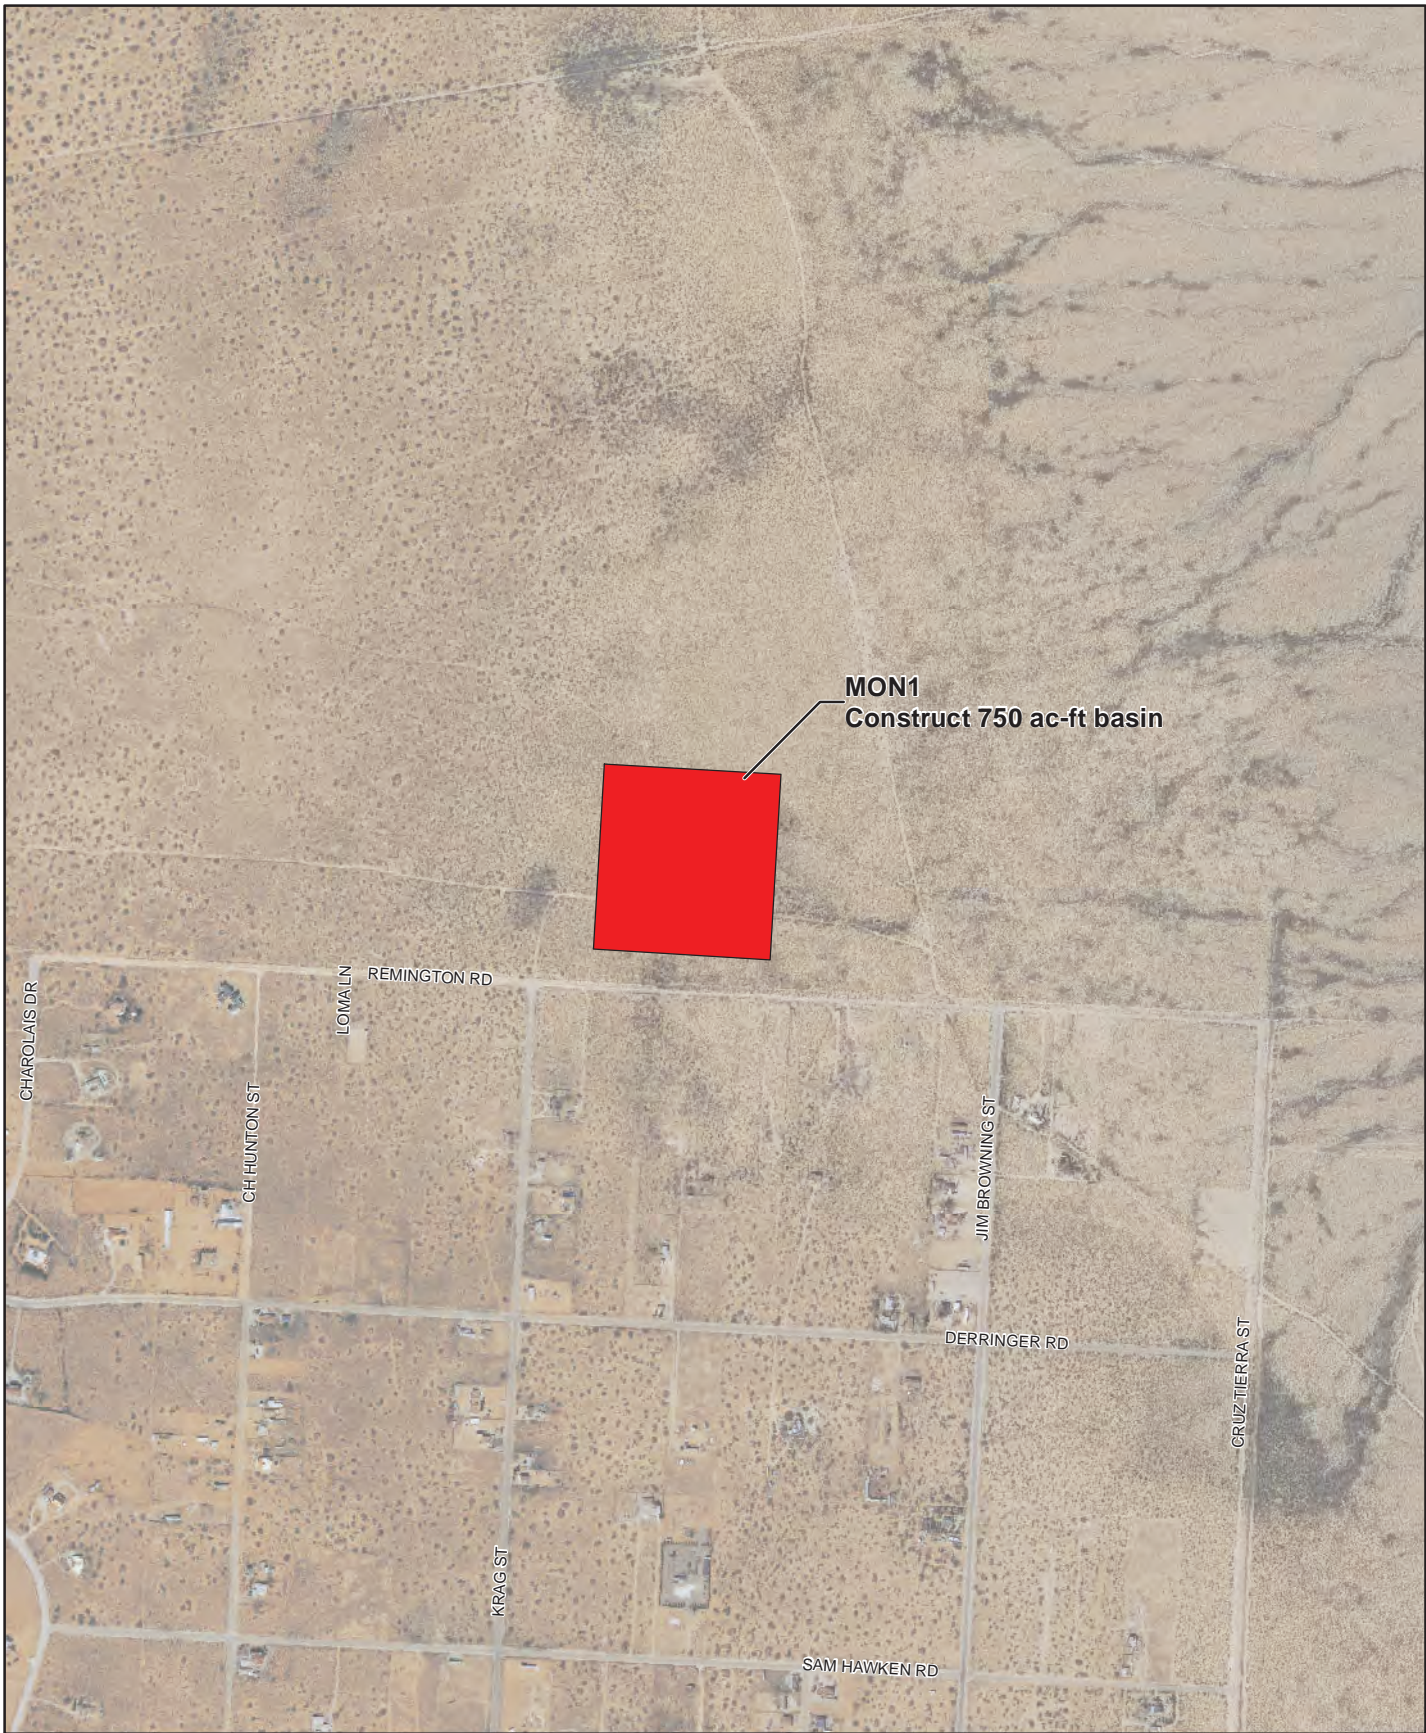
Figure 6-26

MON1
Construct 750 ac-ft basin
