El Paso County Stormwater Master Plan

February 2021

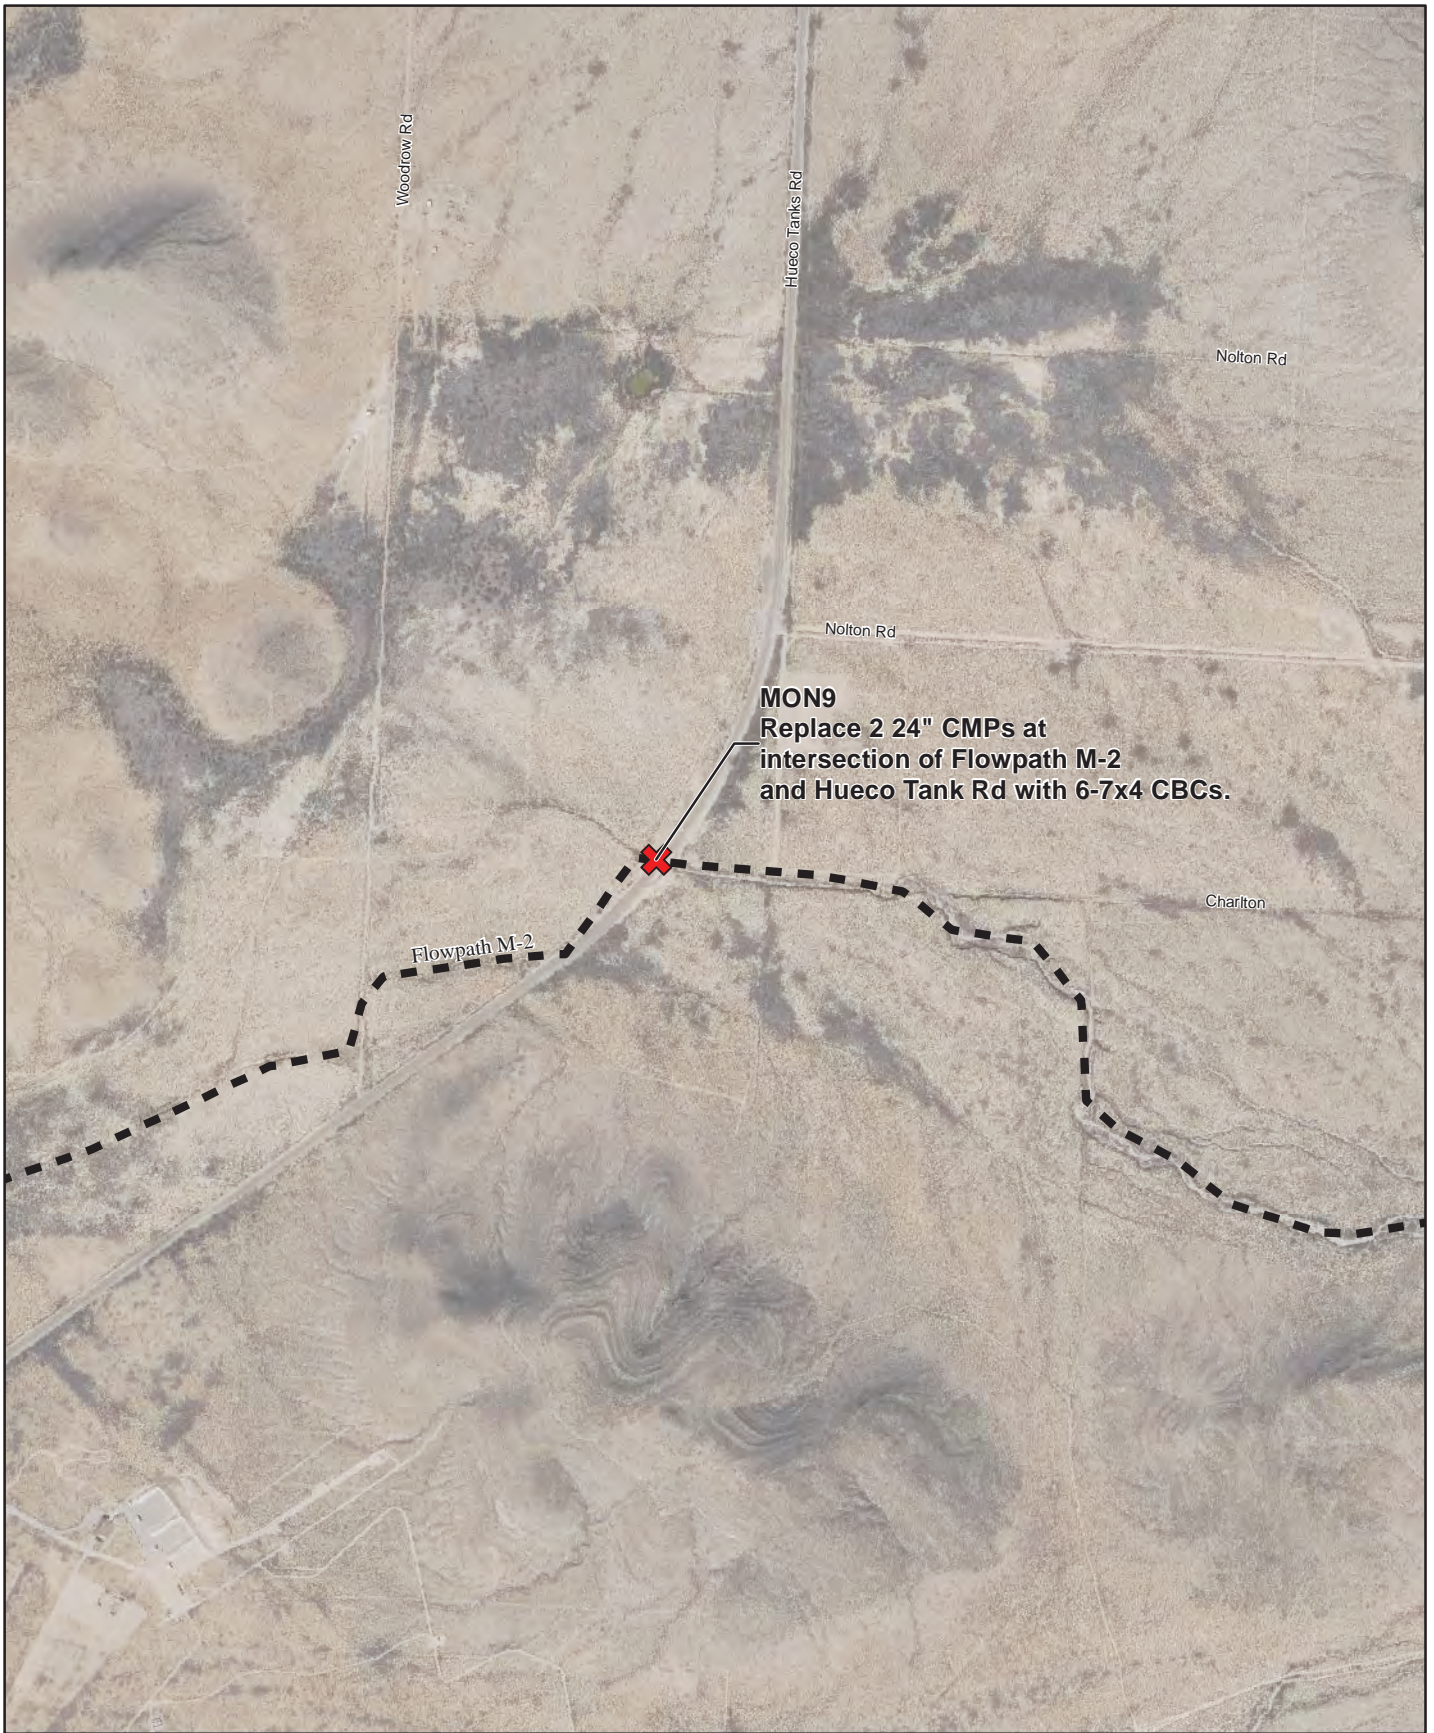
Figure 6-32

MON9
 Replace 2 24" CMPs at
 intersection of Flowpath M-2
 and Hueco Tank Rd with 6-7x4 CBCs.
